### *What happened and where?*

On January 25, 2016 a significant rock slide occurred at Gallagher Lake which impacted a siphon on the canal irrigation system which provides irrigation water to the Town of Oliver, Electoral Area C (rural Oliver), and Osoyoos Indian Band. The break is near station 2+055 on the flume section at Gallagher Lake.

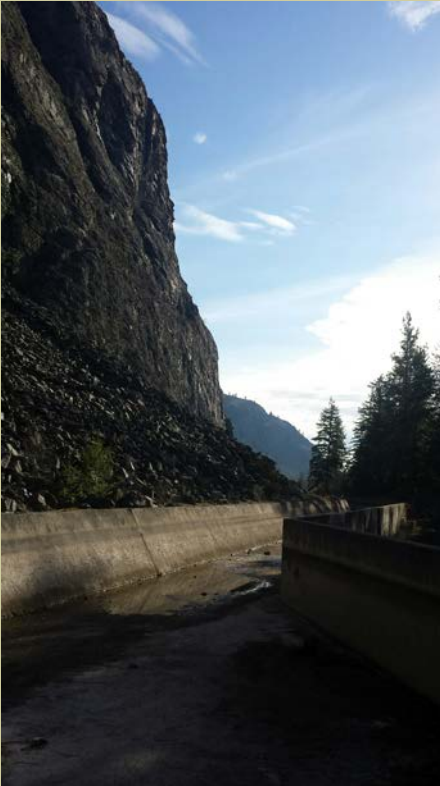
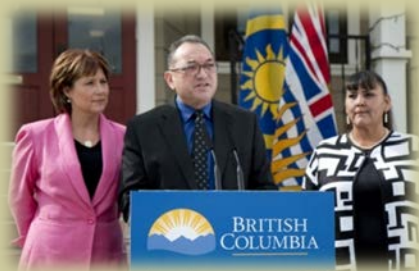
## Pictures

This section of siphon was installed in 1997 to help minimize and eliminate damages to the existing canal system. It is a 1950 mm (78") diameter reinforced concrete pipe buried over with approximately 3 m of fill. It was engineered to withstand a great force if more debris were to fall. The fill was unable to withstand the force and direct damage occurred.

April 1	First break, complete framing forms and culvert setting
April 2	Concrete pour for first fix
April 4	Removal of forms
April 5 to 7	Prepping of second fix, framing forms and culvert setting and patching cracks and seams
April 8	Removal of forms
April 11 and 12	Additional concrete parging, tie-ins and clean-up
April 18	Irrigation Turn On
