March 4, 2016

What happened and where?

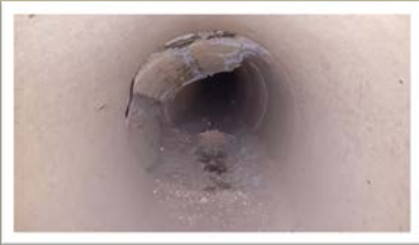
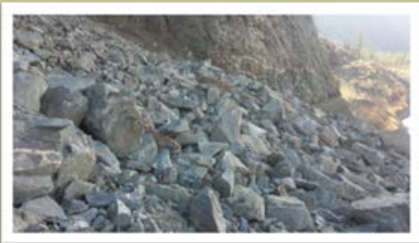
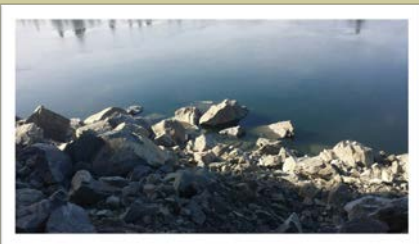
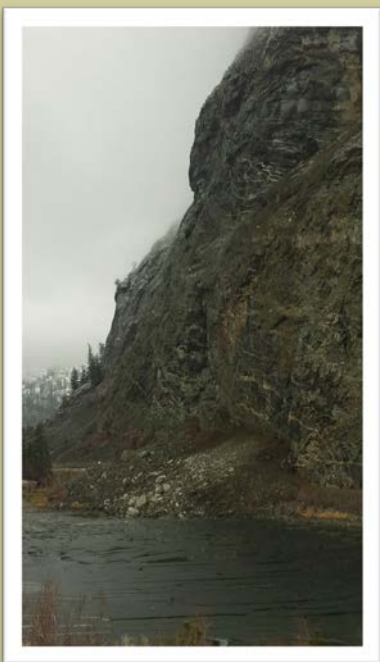
On January 25, 2016 a significant rock slide occurred at Gallagher Lake which impacted a siphon on the canal irrigation system which provides irrigation water to the Town of Oliver, Electoral Area C (rural Oliver), and Osoyoos Indian Band. The break is near station 2+055 on the flume section at Gallagher Lake.

As of Monday, February 29, 2016 geotechnical engineers and rock scalers located significant fractures in the mountain elevating the risk to those working in the area.

To make the work area safe, rock scaling work could take an additional 6 to 10 weeks before repair work to the flume can take place. This additional work could extend beyond the normal irrigation water turn on date, typically scheduled for early April. With additional rock falling there is the possibility of additional damage to the siphon.

This section of siphon was installed in 1997 to help minimize and eliminate damages to the existing canal system. It is a 1950 mm (78") diameter reinforced concrete pipe buried over with approximately 3 m of fill. It was engineered to withstand a great force if more debris were to fall. The fill was unable to withstand the force and direct damage occurred.
