Source Water Assessment REPORT – S2TAG MODULES 1, 2 7 &8 Town of Oliver Groundwater Supply

Project: 14-009-01

Re: FINAL DRAFT report, Town of Oliver Source Water Assessment, Modules 1, 2, 7 & 8

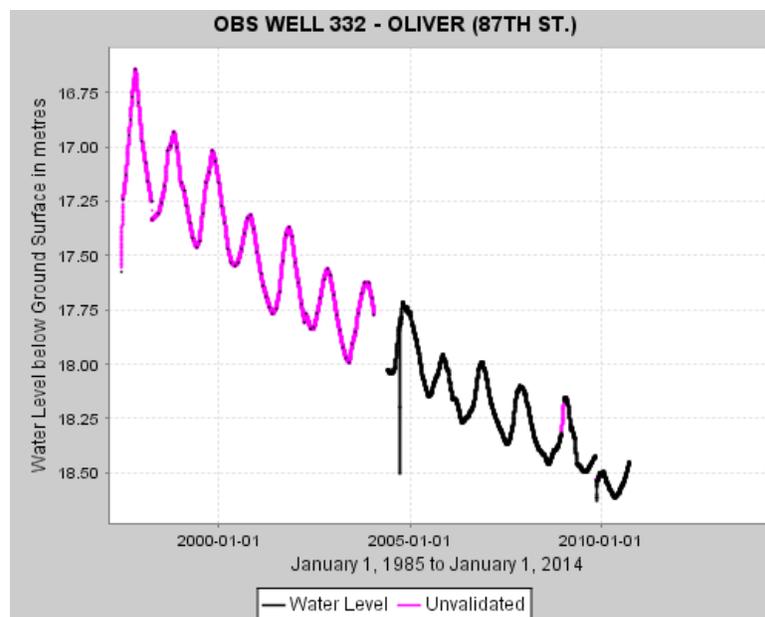
Water levels in Observation wells 405 and 407 (not shown in this report) appear relatively stable or slightly rising in the past couple of years. In contrast, the hydrograph for Observation well 332 (which has a longer period of record) is shown below. Approximately 1.5 m of water level decline is evident from the period of record shown. This well is completed in Aquifer 254, about 1 km north of the Town's Black Sage and Miller Road wells. The data do not appear to have been updated since 2011. See Recommendations for use of this well to inform the Town's groundwater management efforts.
